Case Presentation Made Easy

Case Study Presentation

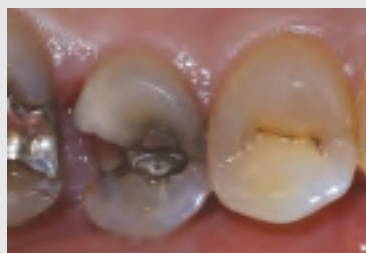
A woman presented with discomfort in the upper right region of the mouth. Clinical examination and radiographs revealed that tooth No. 4 had a large amalgam restoration that was fractured with recurrent decay beneath the restoration extending near the pulp (Figure 1). The patient complained of discomfort on biting hard foods and

Figure 1—Preoperative view of the failing amalgam restoration in tooth No. 4.

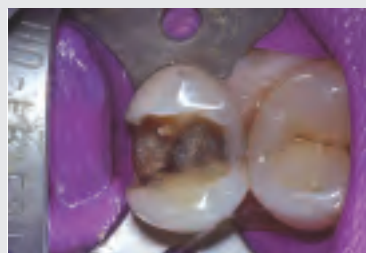
Figure 3—The recurrent decay evident after amalgam removal.

After the patient agreed to the recommended treatment, she was scheduled for the procedure. All the risks, benefits, and alternatives were discussed with the patient. The patient was anesthetized and a dental dam was placed on tooth No. 4. Amalgam removal was achieved using a Barracuda bur (Kisco Dental Products, Wichita, Kan, www.kiscodental.com). Recurrent decay was present underneath the restoration as had been suspected (Figure 3). An intraoral picture was taken to illustrate to the patient exactly how deep the caries had extended underneath the previous restoration. Using the DemoDent model, the progression of decay through the layers of the tooth was further described. Further clean out of decay using a No. 6 round bur revealed that decay had progressed into the pulpal area of tooth No. 4 and that root canal treatment would be required to properly restore the tooth (Figure 4). After root

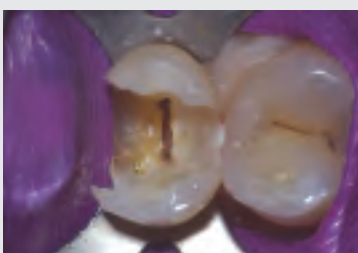
Figure 4—Decay extending into the pulpal area.

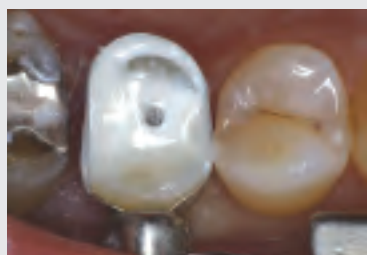
Figure 5—Placing the post and core.

canal therapy was completed, a titanium alloy post (ParaPost, Coltène Whaledent Inc, Cuyahoga Falls, Ohio, www.coltenwhaledent.com) was cemented using an opaque shade of self-etch, self-adhering resin cement (Maxcem, Kerr Corp, Orange, Calif, www.kerrdental.com) and the core was built-up using a dual-core material

(CosmeCore, Cosmedent, Inc, Chicago, Ill, www.cosmedent.com) (Figure 5). Using an LED curing light (L.E.Demetron II, Kerr Corp), the core was cured for 25 seconds. Then the tooth was prepared for a full-coverage crown. Because margins need to be on solid tooth structure and the decay had spread below the gingival

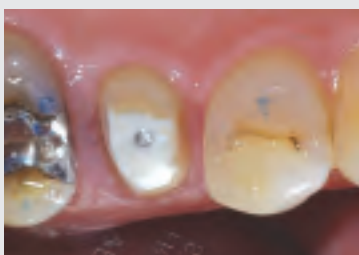
Figure 6—Gingival retraction paste was placed to control bleeding of the soft tissue.

margin, the crown margins were extended subgingivally. A gingival retraction paste (Expasyl, Kerr Corp) was used to control the bleeding of the gingival tissues (Figure 6). After hemostasis was achieved, an impression was taken using a polyvinylsiloxane material (Take 1, Kerr Corp).

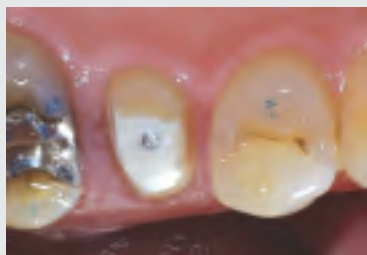
Figure 7—Clinical view of the final preparation at the re-evaluation appointment.

Two weeks later the patient returned for placement of the porcelain-fused-to-metal crown. The provisional restoration was removed and the preparation was inspected for final cementation (Figure 7). After a bitewing x-ray was taken to confirm full seating of the crown and the contacts and margins verified, the crown restoration was cemented (Maxcem, Kerr Corp). The patient was very pleased with the final restoration (Figure 8).

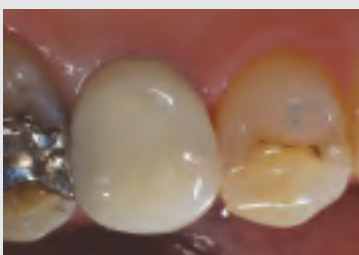
Figure 8—Final porcelain-fused-to-metal restoration.
