# A Simple Esthetic Alternative Using Eris Crowns

Ara Nazarian, DDS  
Private Practice  
Premier Dental Center  
Troy, Michigan  
Phone: 248.457.0500  
Email: ara20002@comcast.net

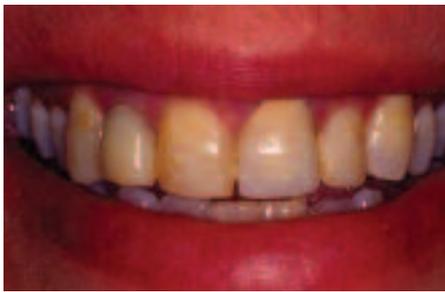
on her anterior teeth were "old and dingy looking." The patient was extremely dissatisfied with the entire appearance of her smile (Figure 1) and desired straighter, whiter teeth.

**Figure 1**—Preoperative view of patient's smile.

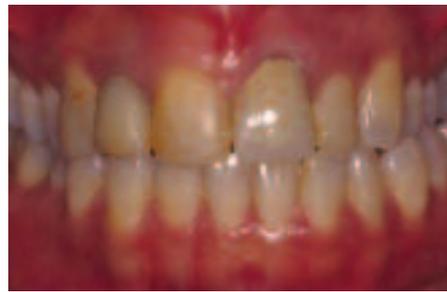
A clinical examination revealed multiple composite restorations with recurrent decay, an unesthetic PFM crown, and an endodontically treated tooth that exhibited severe discoloration and staining (Figure 2). Occlusal wear was evident on the canines and lateral incisors, resulting in very flat, square anterior teeth. She did not have temporomandibular joint symptoms at this time, but the ultimate treatment plan was to include the development of anterior protection of the posterior teeth with canine guidance and a maxillary acrylic occlusal splint.

**Figure 2**—Preoperative retracted view showing discolored, unesthetic teeth.

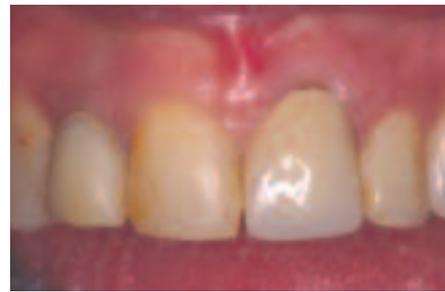
**Figure 3**—Preoperative close-up of anterior maxillary teeth.

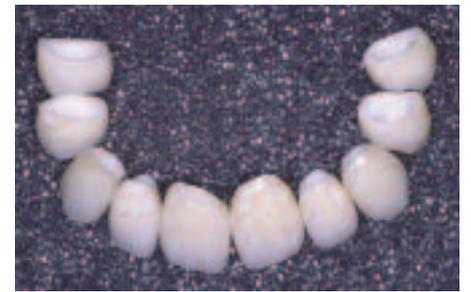
**Figure 4**—Completed IPS Empress Eris restorations.

After the provisional restorations were removed, the preparations were cleansed with plain pumice (Pumice Preppies, Whip Mix Corporation) and then cleansed with chlorhexidine. The preparations were then desensitized (Systemp desensitizer, Ivoclar Vivadent, Inc), and the final IPS Empress Eris restorations (Figure 4) were tried-in to verify marginal fit, contour, contacts, shade, and accuracy. The patient was very satisfied with the appearance of her new restorations, which she approved for final cementation. The IPS Empress Eris restorations were seated using a self-curing, Type-I glass ionomer cement (VivaGlass Cem, Ivoclar Vivadent, Inc). Excess cement was easily

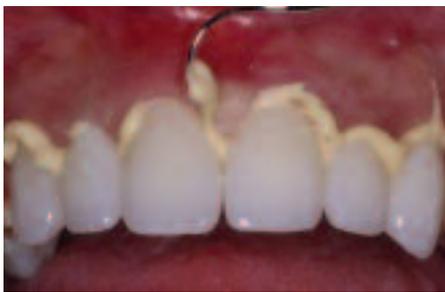
**Figure 5**—Excess cement is easily cleaned up when in its "doughy" stage.

removed from the margins and accomplished quickly because of the "doughy" consistency of this cement (Figure 5). The finishing of the cement was not necessary along the margins.

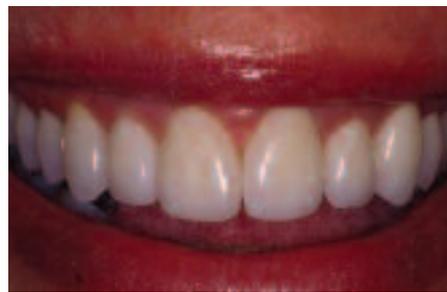
**Figure 6**—Postoperative view of the patient's natural smile.

IPS Empress Eris crowns represent an alternative restorative material that enhances the dentist's and technician's ability to provide durable, esthetic, and functional restorations in the anterior or posterior region of the mouth, especially when metal-free restorations are a primary desire of the patient (Figures 6 through 8). The IPS Empress Eris restorations and similar products introduce yet another method of meeting the demands of today's society. ■

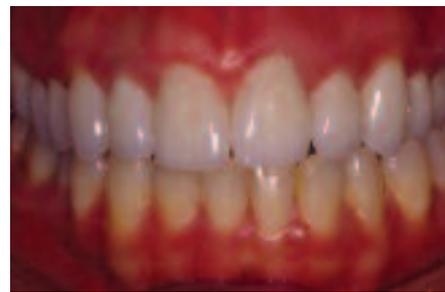
**Figure 7**—Postoperative retracted view of the patient's dentition.

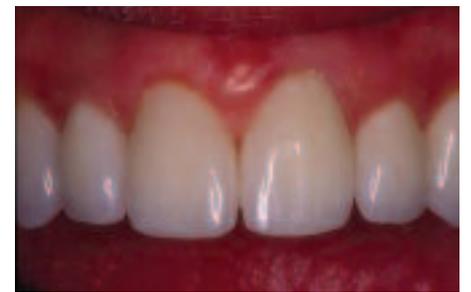
**Figure 8**—Postoperative 1:1 view of the maxillary restorations.
